Verification Report - Forest Restoration for Carbon Sequestration in West Bugwe Central Forest Reserve, Uganda

COMPARTMENT/SITE DETAILS

Site photos of October 2021 Crop

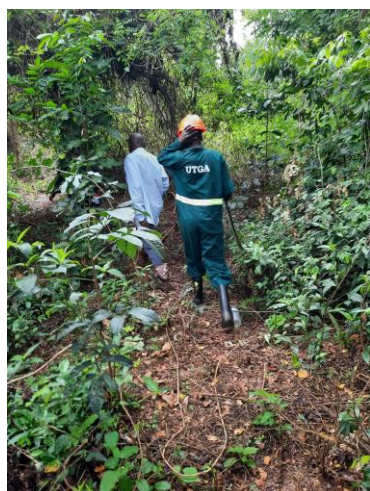
Forest access impaired by invasive weeds

- The area has high potential for natural regeneration, the ideal approach should be to target and remove invasive weeds routinely and keep off forest disturbance (from humans and animals) to facilitate natural regeneration.
- Implement Farmer Managed Natural Regeneration (FMNR) approaches to liberate wildlings of valuable species and planted seedlings from climbers and aggressive weeds.
- Implement a strong policy on Kaveera and plastics (together with NFA) to prevent the locals from dumping non-biodegradable wastes at the periphery of the forest to demonstrate a sustainable and environmentally friendly intervention.
- Re-introduce tree species (non-invasive species) that provide food to the wildlife as a biodiversity strategy.

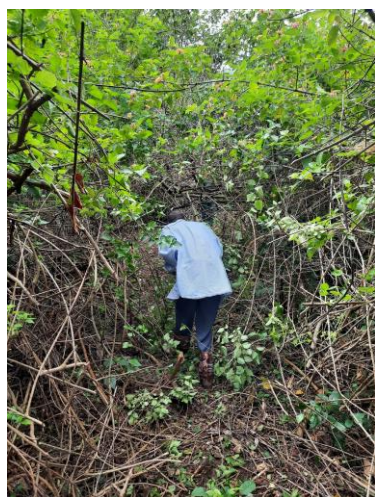
5.	Weeding	✓		Weeds well controlled, within the two meters wide trails. However, a number of wildlings (natural regeneration) were observed along the trails. Invasive weeds especially <i>Lantana camara</i> are fast spreading, hindering access and blocking as well seedlings from accessing sunlight in some of the restored sections.

Lantana Camara spreading fast in the area, obstructing movement along the trails.

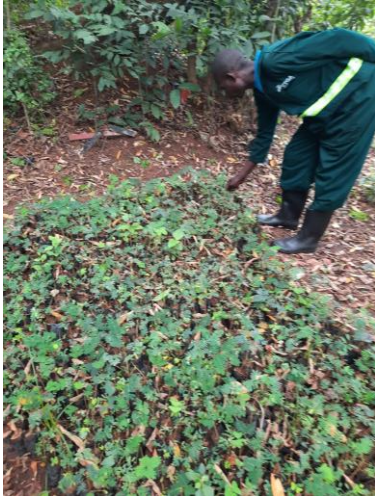
Seedlings for beating up at the holding nursery

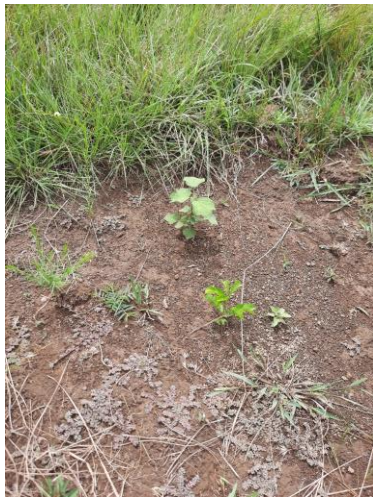
Seedlings established and growing well. However, the one meter ring is getting weedy

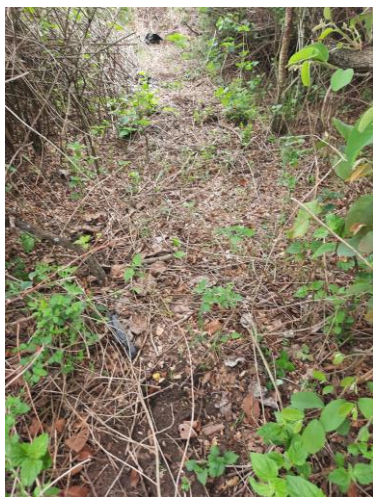
Natural regeneration along the trails, showing potential for Assisted Natural Regeneration in the area.
